Test Report No. 719170270-MEC10-LNB
dated 08 March 2010

SUBJECT:

Testing on Waterless Urinal Maintainer

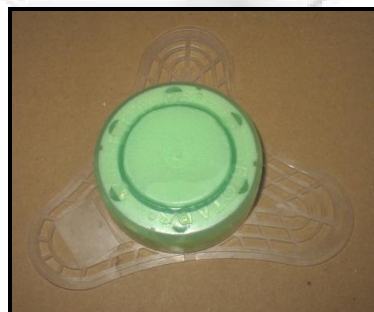
A waterless urinal maintainer was received on 22/2/2010

Product Name : BIOTABS WATERLESS URINAL DEODORIZER/DRAIN MAINTAINER

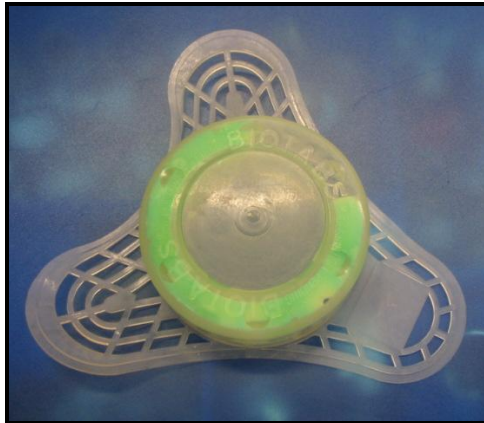
The condition of sample after 20,980 cycles of flushing

Top View of Sample after the Test

1. The test sample was placed in a urinal with a flush valve under normal condition.
2. The flush valve was activated at a pre-determined time interval of 15 seconds and the flow volume was controlled at 500 ml.
3. The test will run continuously and stop when the sample has dissolved, as agreed with the client. The number of cycles was then noted.

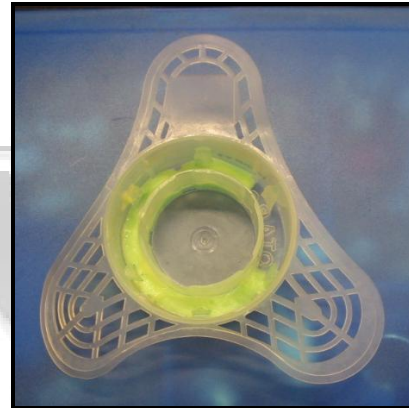
Bottom View of Sample after the Test
